THE WATERFRONT ON THE OCEAN
MILESTONE INVESTIGATION REPORT
PHASE I

THE WATERFRONT ON THE OCEAN CONDOMINIUM
800 OCEAN DRIVE
JUNO BEACH, FL 33408

MILESTONE INSPECTION REPORT
OCTOBER 2023

PHASE I

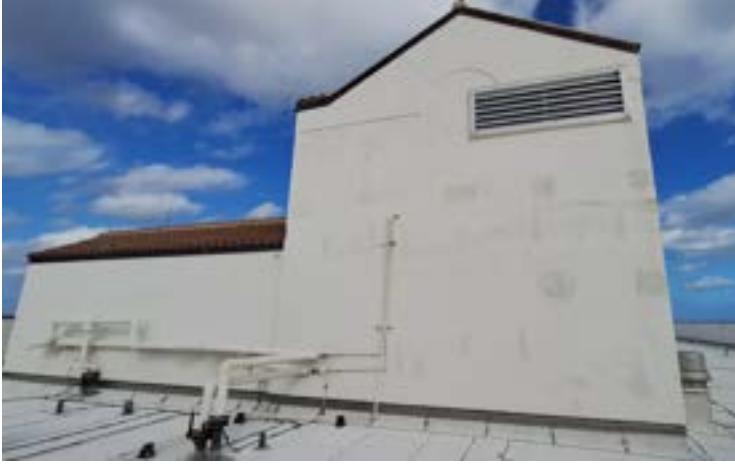
Exterior Stucco Wall at Roof Elevator Room

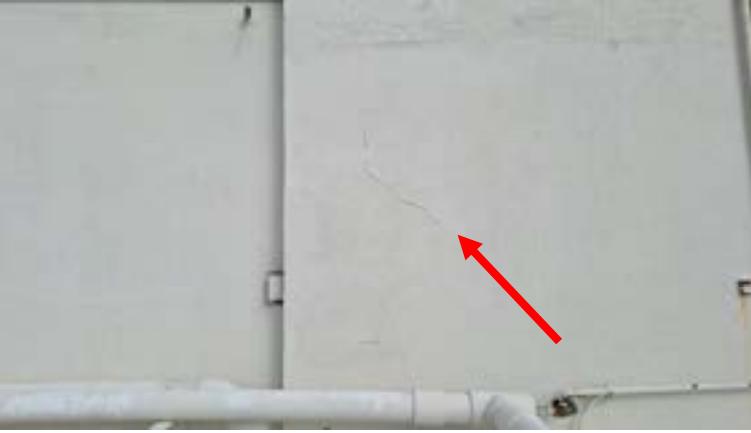
Stucco Cracks at Exterior Wall at Roof Elevator Room

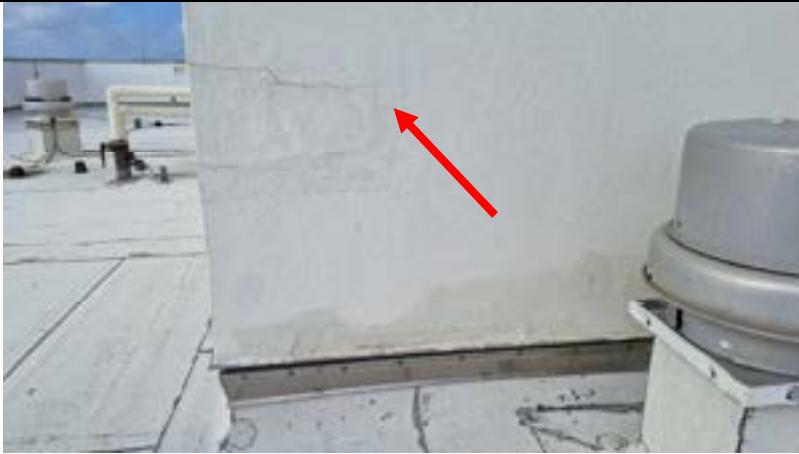
Stucco Cracks at Exterior Wall at Roof Elevator Room

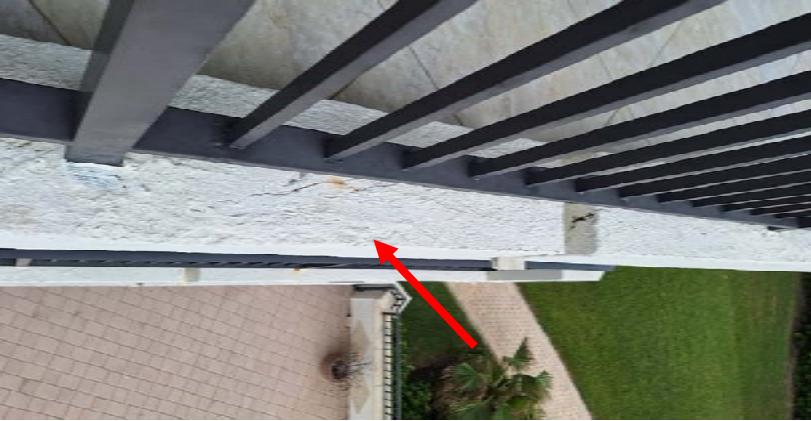
Cracks in Block Wall Railing

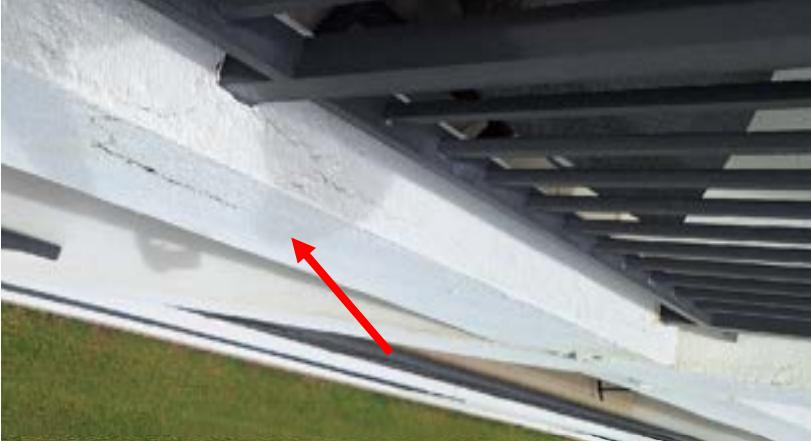
Concrete Spalling in Block Wall Railing

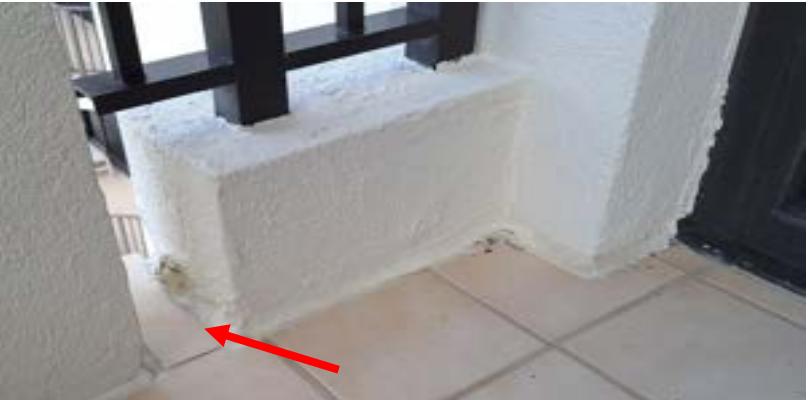
Rust Spot in Block Wall Railing

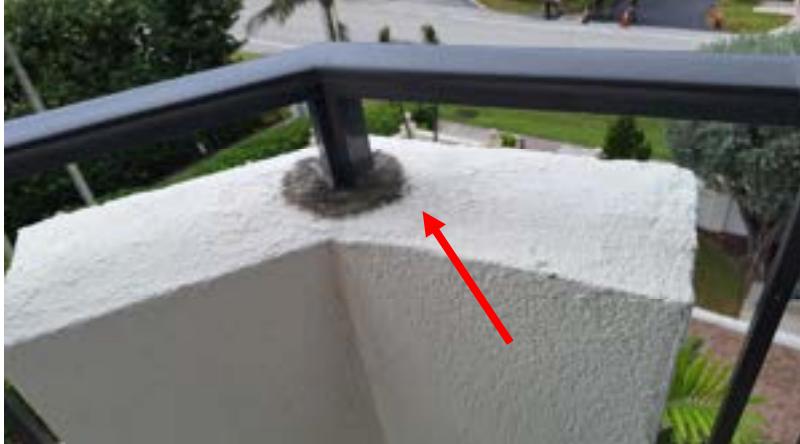
Deteriorated Rail Post Pocket at Balcony with Water Intrusion

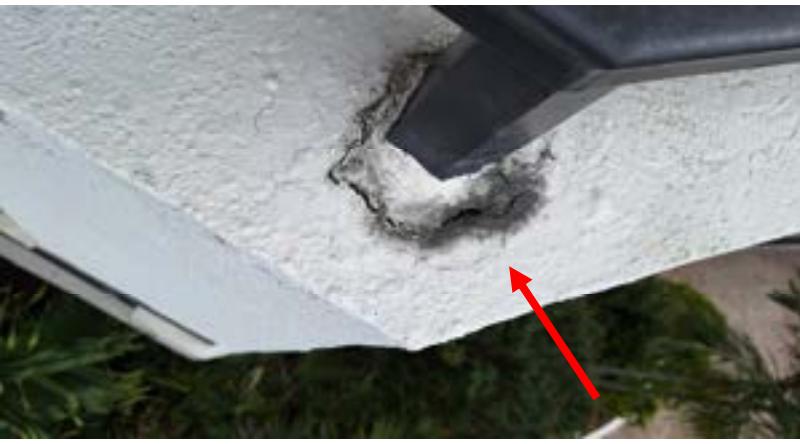
Deteriorated Rail Post Pocket at Balcony with Water Intrusion

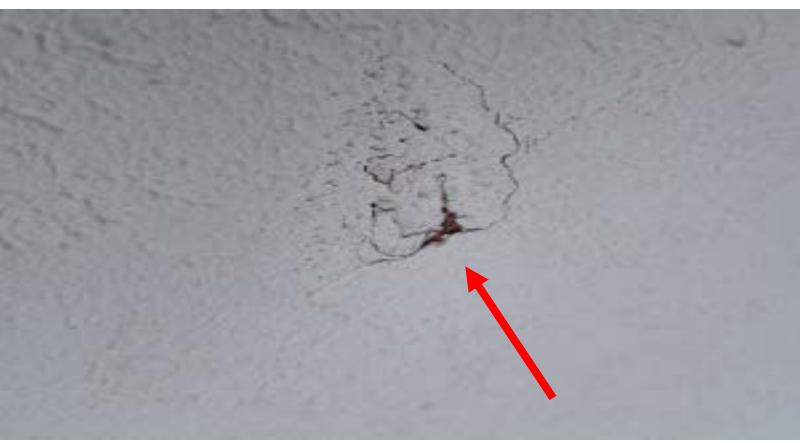
Stucco Cracked and Missing at Balcony Wall

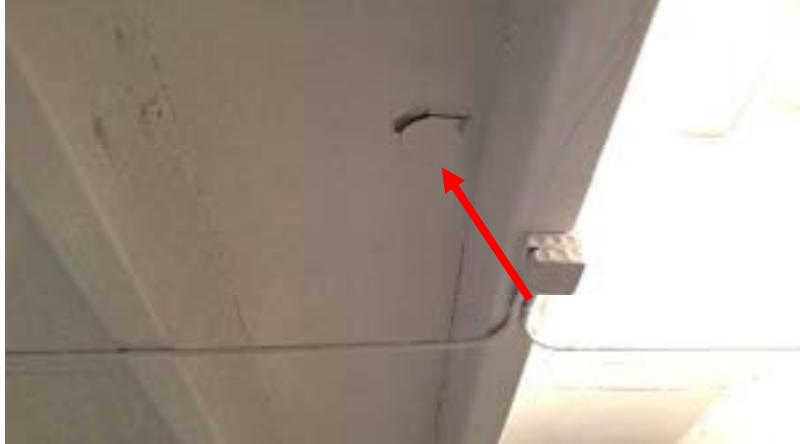
A photograph showing a vertical concrete slab with a horizontal crack. A red arrow points to the right side of the crack, indicating the location of the spall.	Overhead Concrete Slab Spall, Parking Spot #85

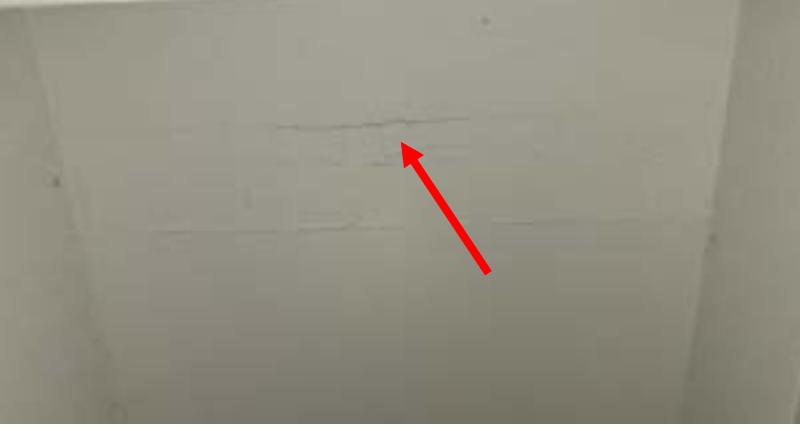
A photograph showing a vertical concrete slab with a horizontal crack. A red arrow points to the right side of the crack, indicating the location of the spall.	Cracks In Overhead Concrete Slab, Parking Spot #49

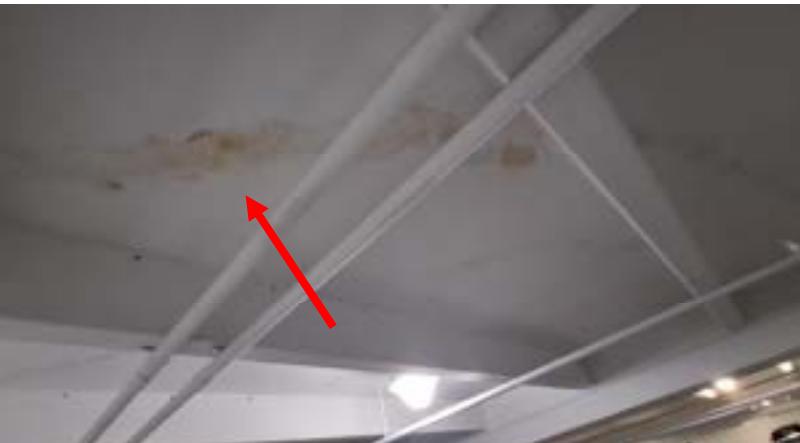
A photograph showing a concrete slab with water stains. A red arrow points to the left side of the slab, indicating the location of the stains.	Water Stains at Overhead Concrete Slab, Parking Spot #80

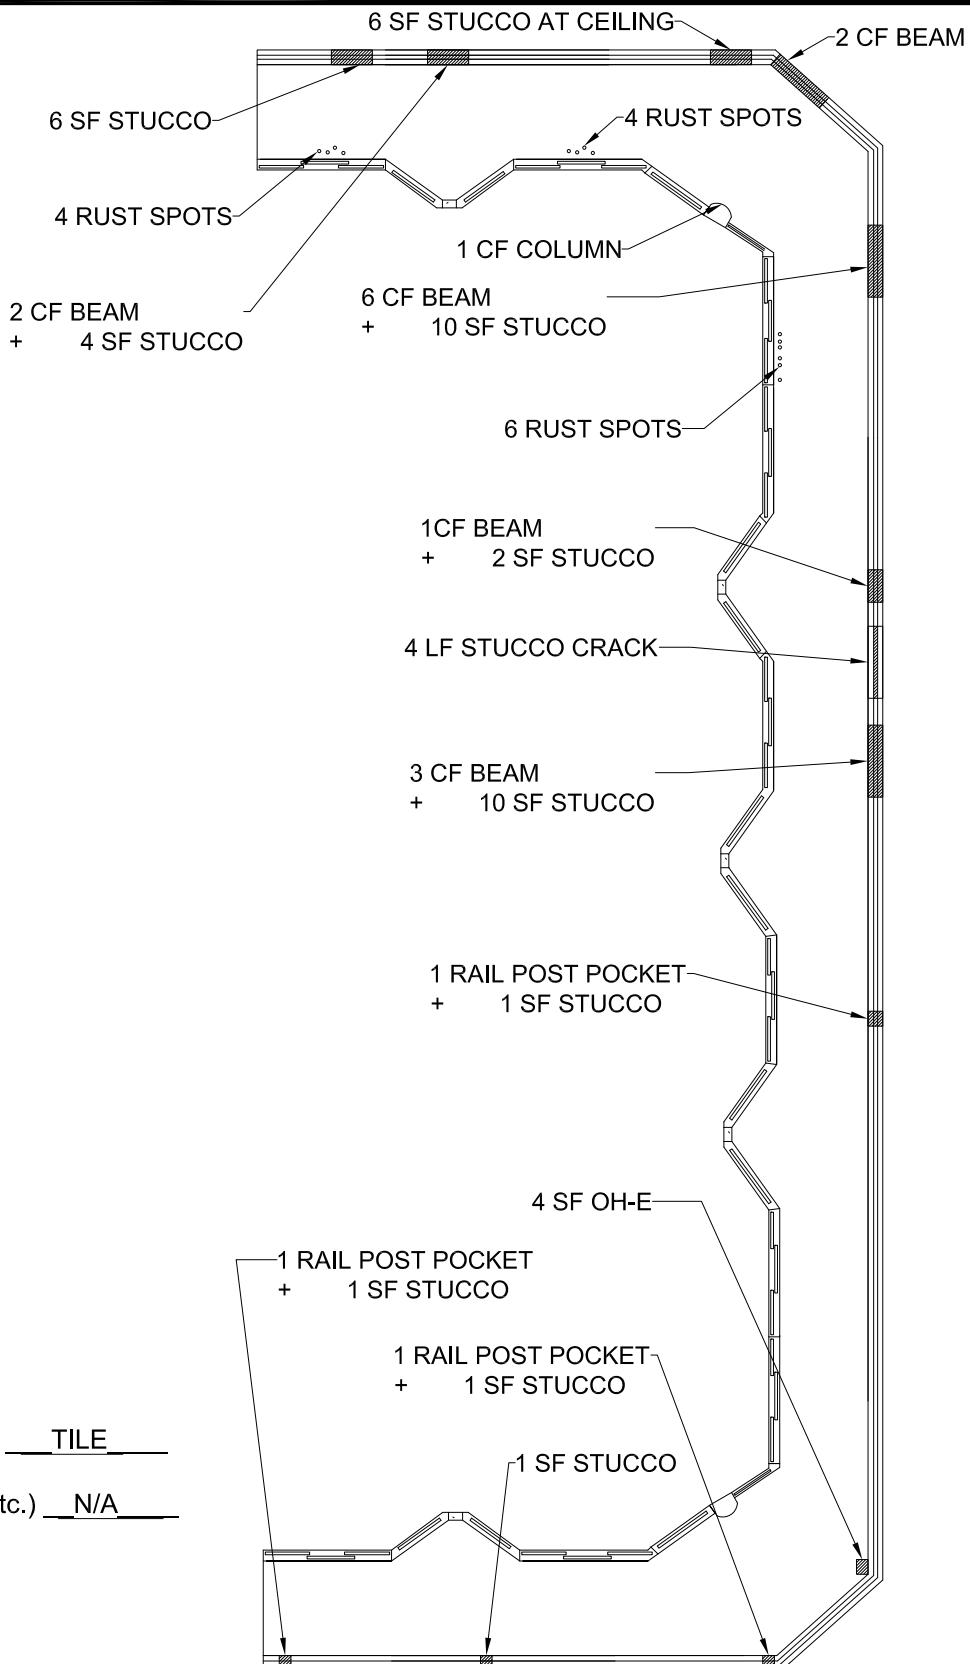
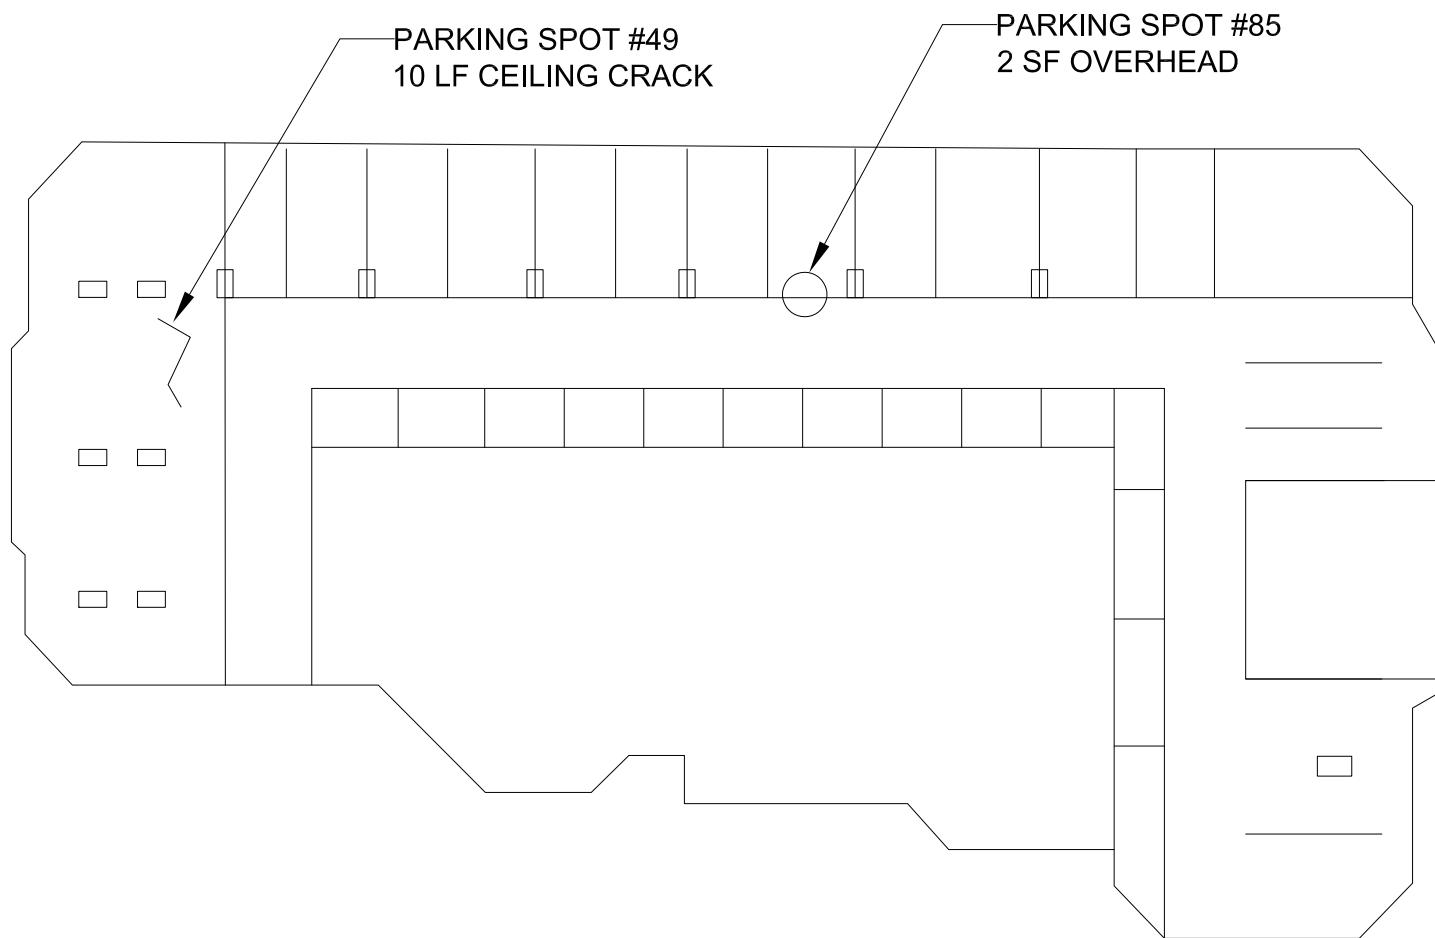
GARAGE

Ceiling Crack 10 LF

Ovrhd Repair 2 SF
