THE WATERFRONT ON THE OCEAN
MILESTONE INVESTIGATION REPORT
PHASE I

THE WATERFRONT ON THE OCEAN CONDOMINIUM
800 OCEAN DRIVE
JUNO BEACH, FL 33408

MILESTONE INSPECTION REPORT
OCTOBER 2023

PHASE I

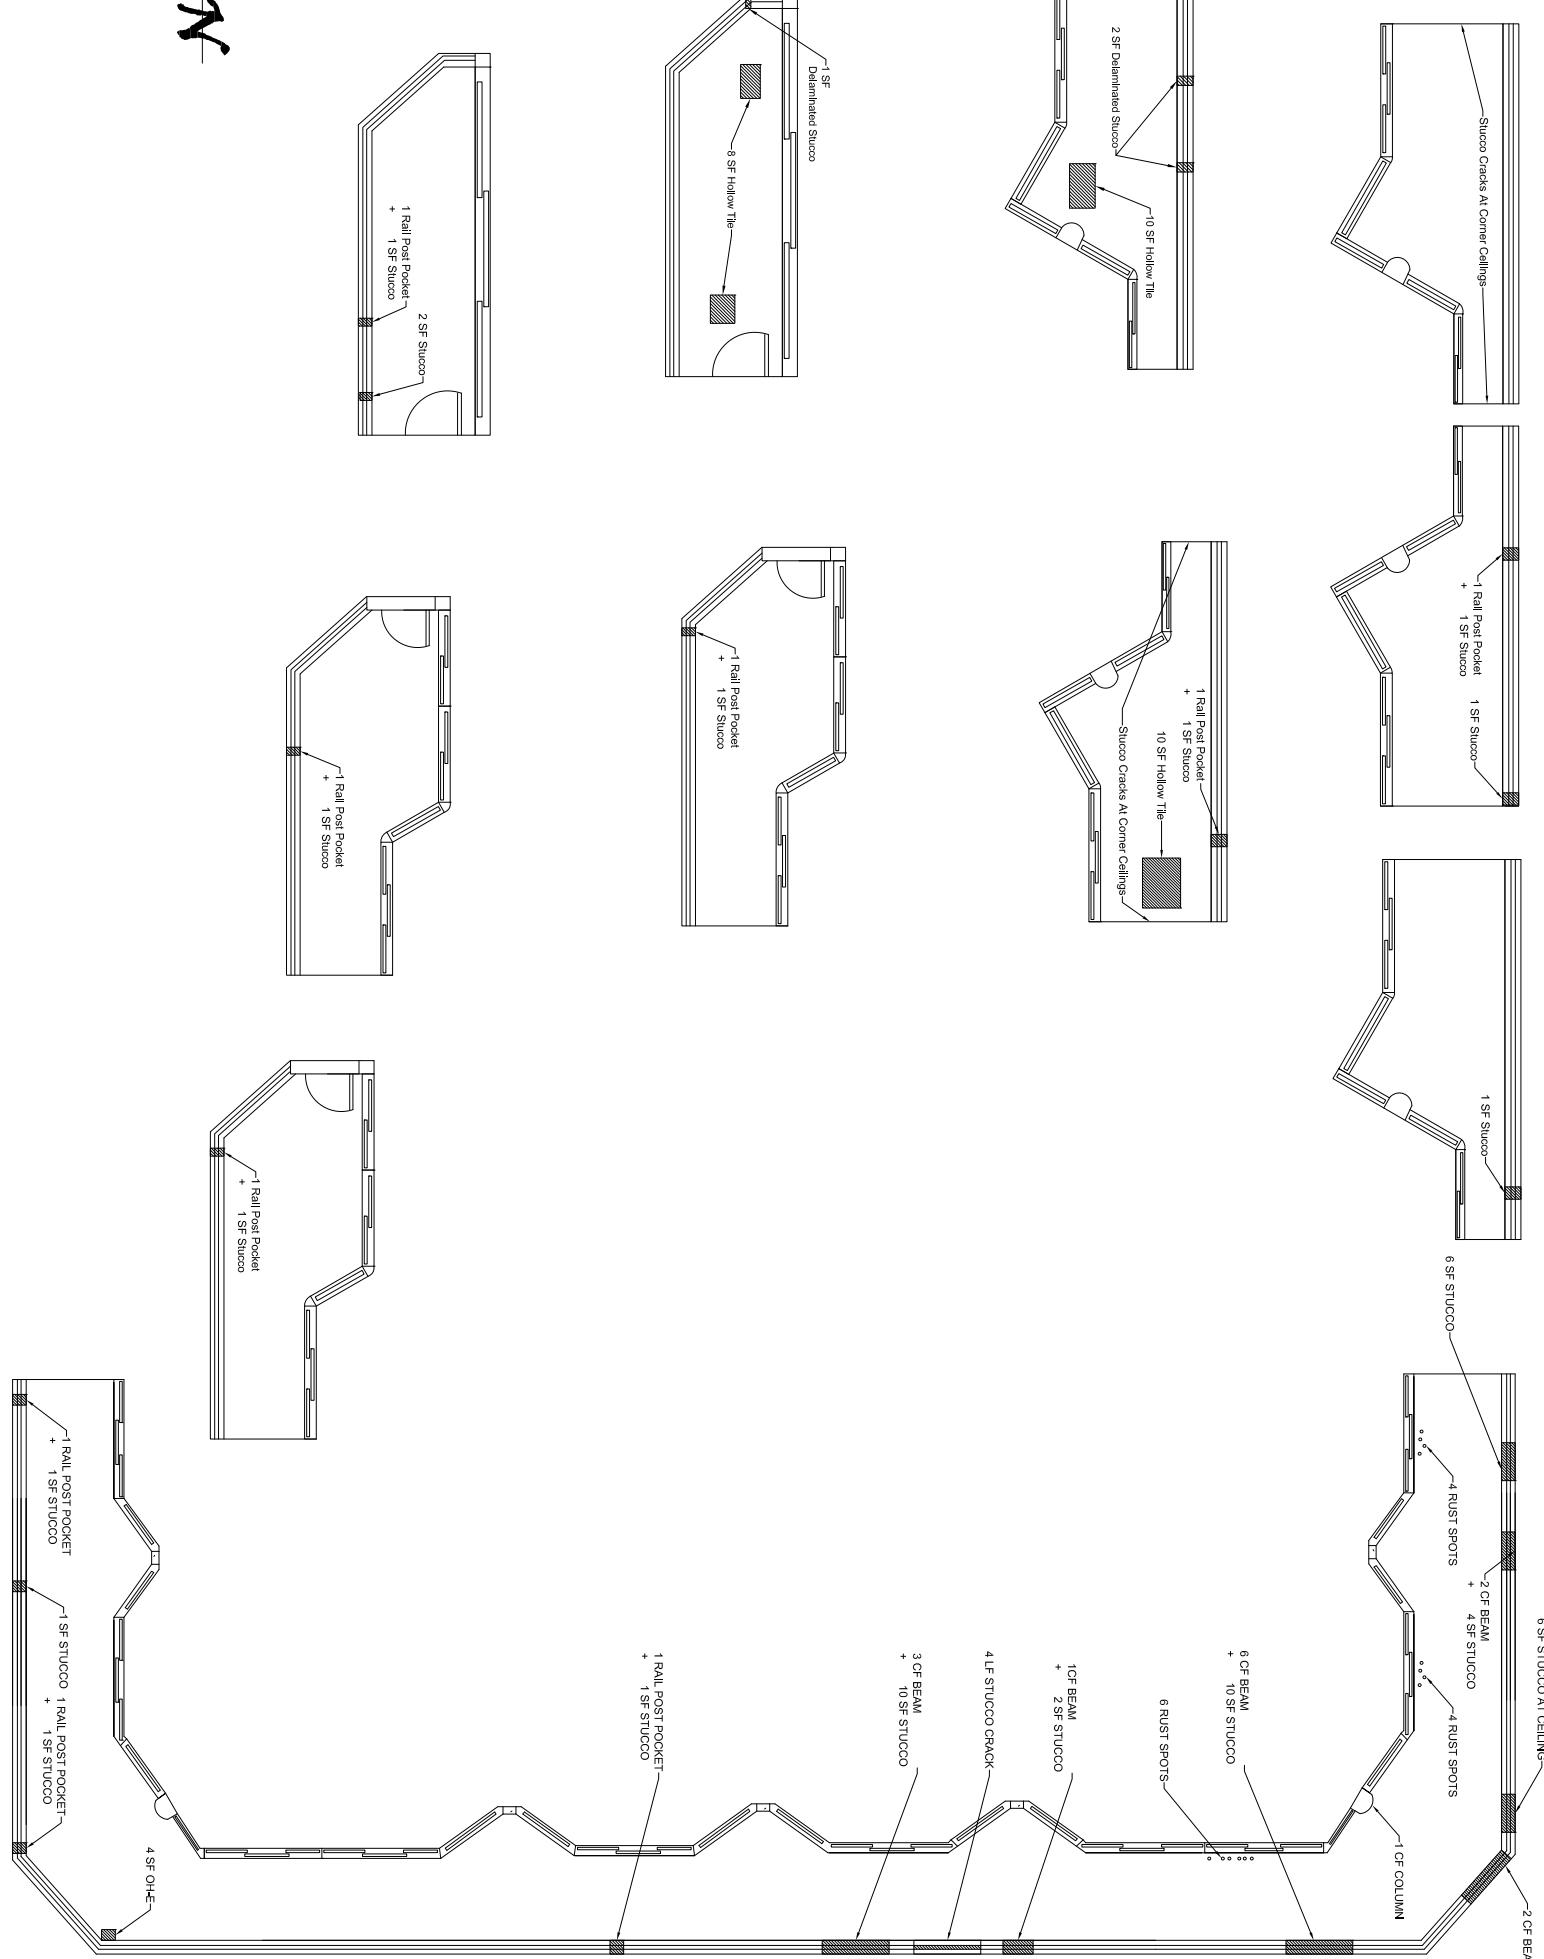
CONCRETE SURVEY
WATERFRONT ON THE
OCEAN CONDOMINIUM
800 OCEAN DRIVE,
JUNO BEACH, FL 33408

Ovrhsd Edge	2	LF.
Ovrhsd Repair	4	SF
Column Repair	1	CF
Beam Repair	14	CF
Rail Post Pocket	9	EA
Stucco Repair	55	SF.
Stucco Repair	55	SF.
Hollow Tile	28	SF.
Ceiling Crack	10	LF.
